Old salt silo ready for concerts

From salt silo to cultural center

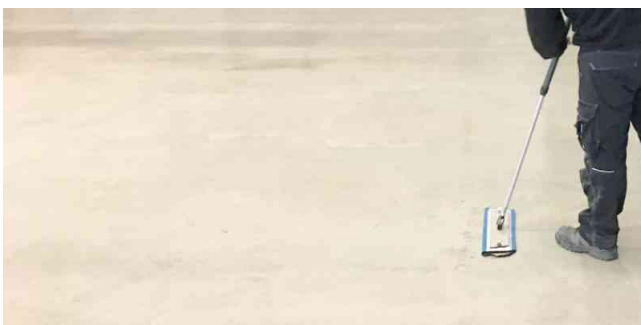
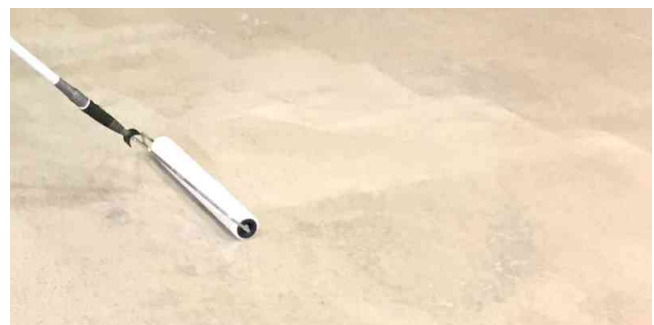
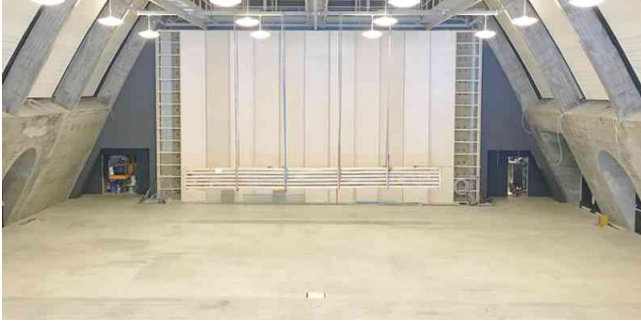
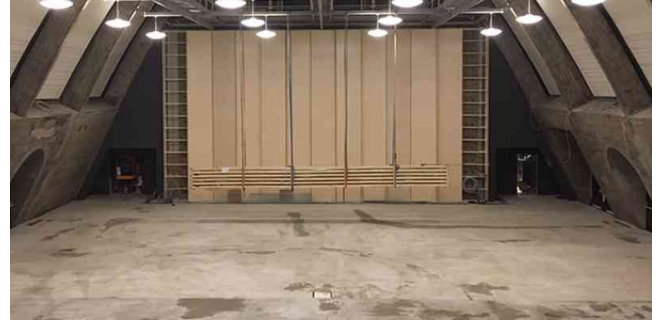
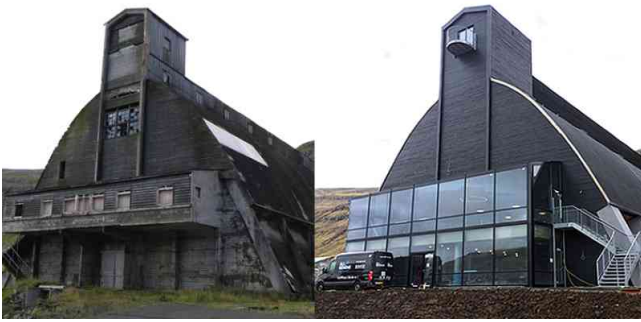
Treated vs. untreated Salt Silo

Before opening the doors to the public, there was a concrete floor that needed fixing. The interior concrete floors had fissures and crevices that were significantly large.

With the cooperation of a local concrete company, the floor slab was sanded. Then, All Remove employees repaired the floors with ARD Revnestop (ARD fissure stop), which is a strong glue that binds surfaces together. After solidification, the floor was sanded again.

All Remove has impregnated approximately floor surfaces of 50,000 m² with FACEAL Matlook, which is especially designed for the Nordic market. The treatment leaves a dull and almost invisible top coat surface.
