## Old salt silo ready for concerts

### From salt silo to cultural center

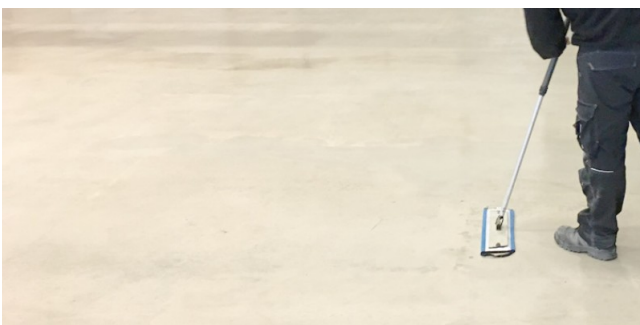
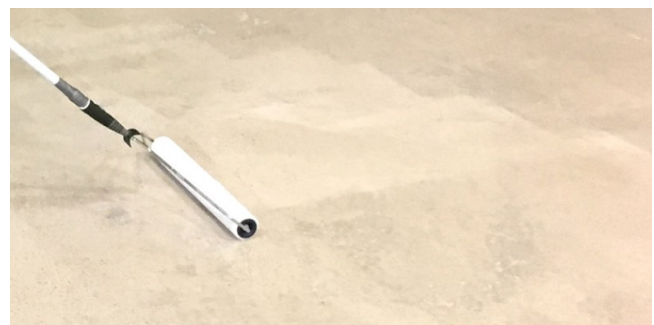
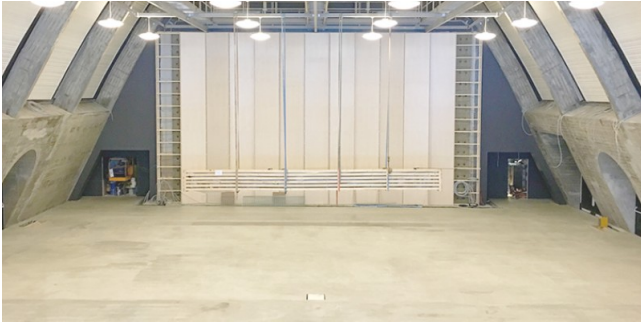
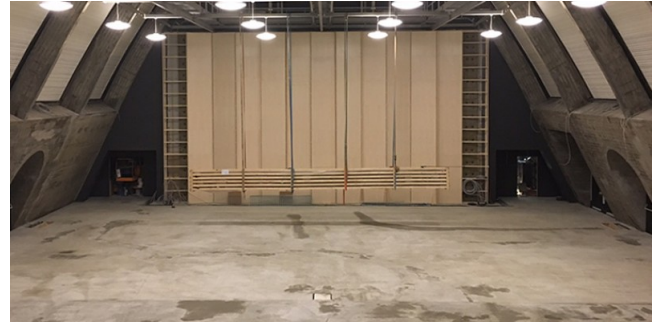
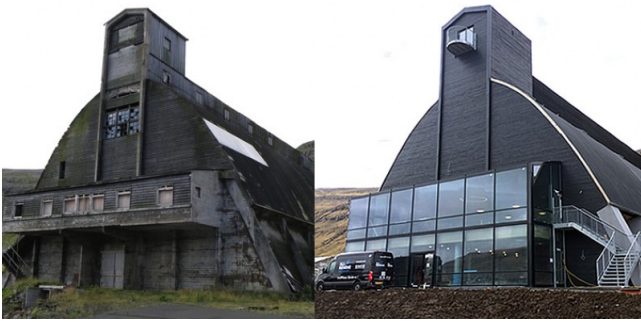
Treated vs. untreated Salt Silo

Before opening the doors to the public, there was a concrete floor that needed fixing. The interior concrete floors had fissures and crevices that were significantly large.

With the cooperation of a local concrete company, the floor slab was sanded. Then, All Remove employees repaired the floors with ARD Revnestop (ARD fissure stop), which is a strong glue that binds surfaces together. After solidification, the floor was sanded again.

All Remove has impregnated approximately floor surfaces of 50,000 m<sup>2</sup> with FACEAL Matlook, which is especially designed for the Nordic market. The treatment leaves a dull and almost invisible top coat surface.
