Thorough cleaning makes concrete walls at IKEA as good as new

The largest IKEA in Denmark is located in Odense. The department store has two floors, and if you walk through all the sections, the trip is no less than 2.5 kilometers long.

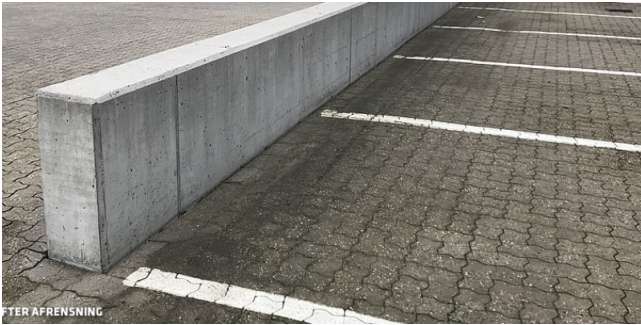
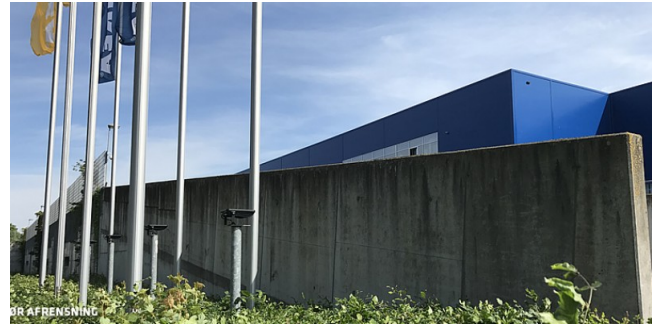
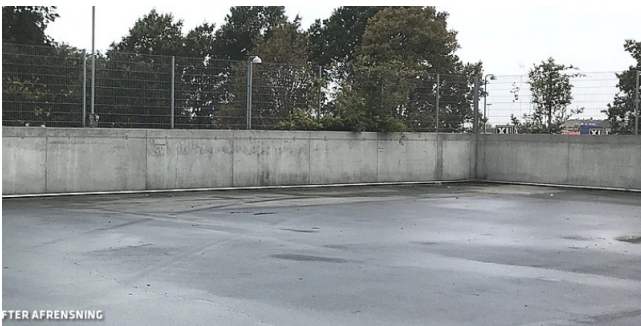
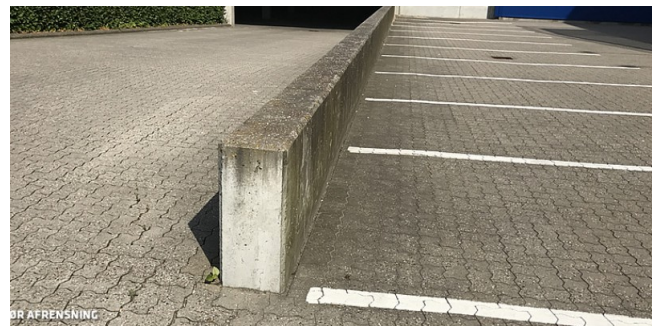
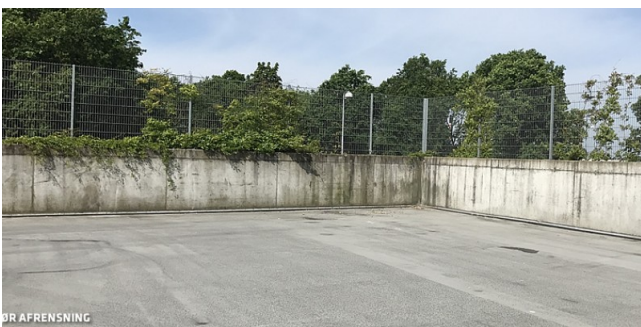
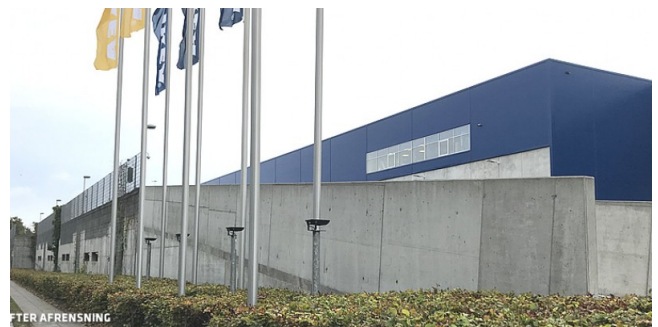
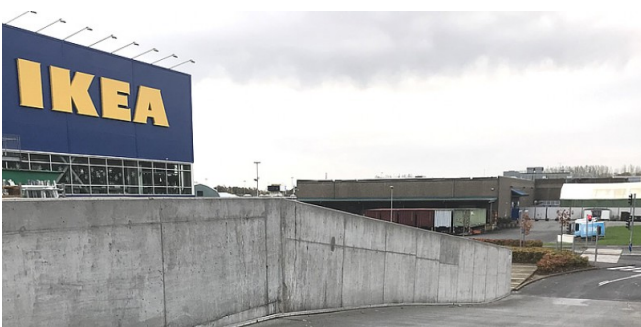
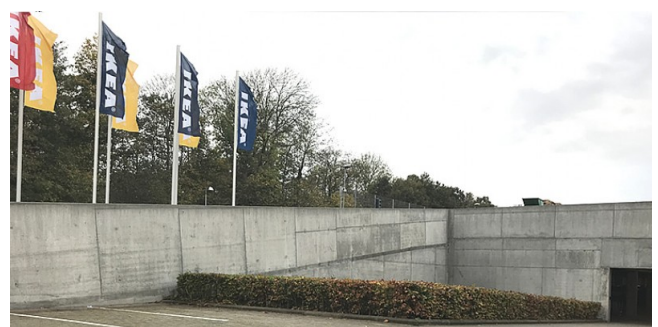
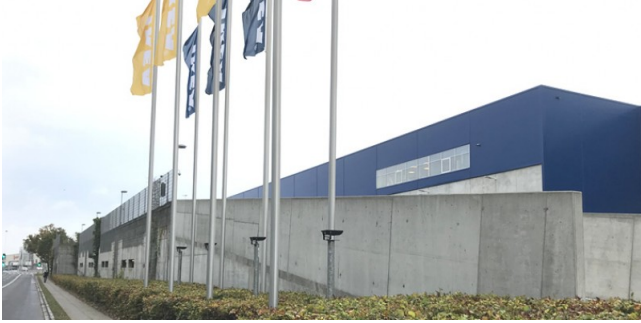
But because the walls were not impregnated back in 2009 when the store was built, the algae flourished on the walls and large curtains of filth were running down the sides.

First, the concrete was cleaned using hot water high-pressure cleaners. After the cleaning, all algae and dirt had been removed making the concrete surfaces light and uniform again.

Next, all the surfaces were impregnated with Faceal Oleo HD. This protection will make the

walls look presentable and clean for many years to come.
